Inspection Report
Nowhere Important
Rural, OR
Prepared for: Nobody You Know

Report Table of Contents

REPORT #: 12144.
DATE OF INSPECTION: 1/7/2008.
TIME OF INSPECTION: 9:00 AM.
CLIENT NAME: Nobody Important.
CLIENT CITY/ STATE/ZIP: ,
CLIENT PHONE #: 503-555-5555.
CLIENT FAX #:
INSPECTION SITE: Country LN.
INSPECTION SITE CITY/STATE/ ZIP: Rural, OR.

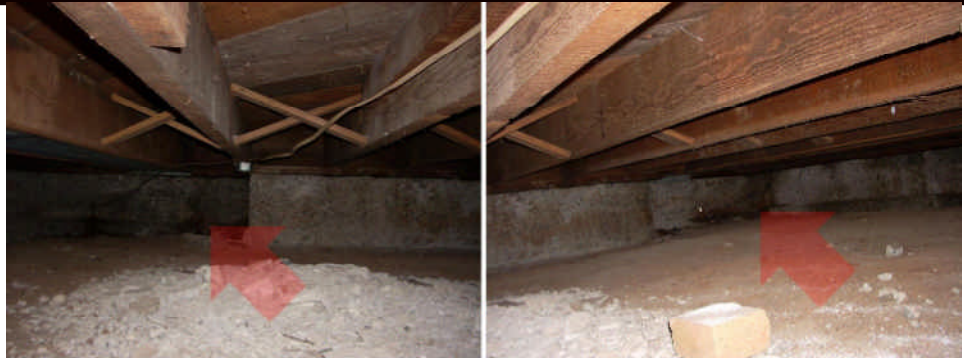
Remove all wood debris from crawlspace, The following wiring **deficiencies** were noted, Wiring is hanging and not properly secured to framing, Wiring not terminated in junction boxes- open ends of wiring/rommex under kitchen- budget for repairs. **Flashlight** vision only to crawlspace under living room due to insufficient size opening in foundation wall- recommend improve opening size and check area for possible pest/dry rot damage- wet sills/rims noted in areas.

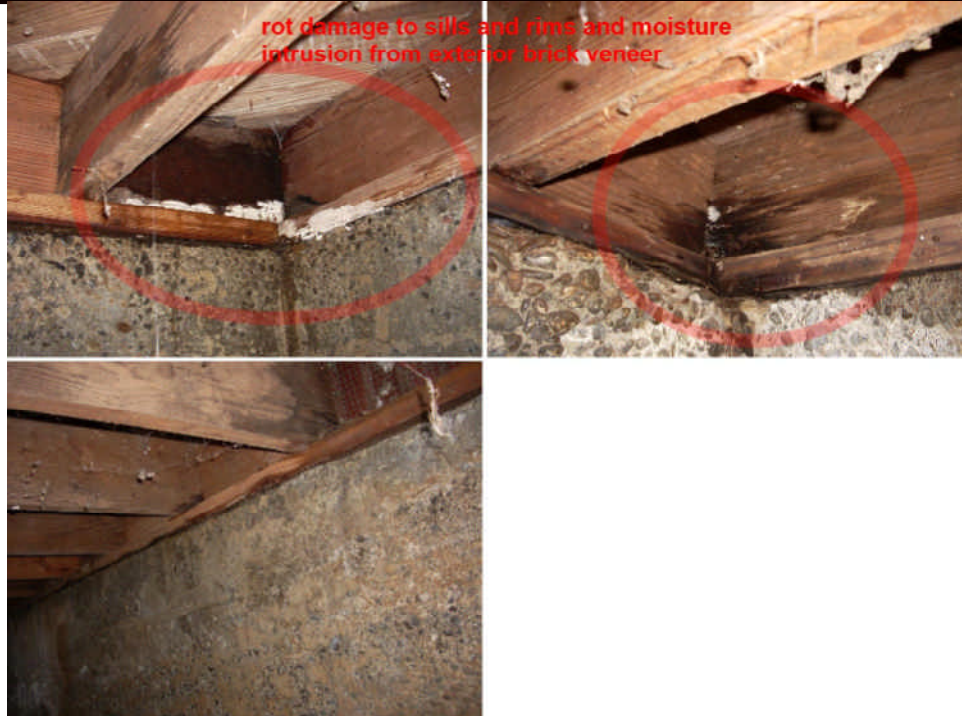
Dry rot damage noted in, Rims and mudsill at NW kitchen and at SE corner of SE bedroom. Due to clearances and access openings- unable to evaluate under living room crawlspace. Water dripping off foundation and sills at multiple areas due to moisture intrusion from exterior brick veneer. Recommend licensed general contractor evaluate and repair all damage.

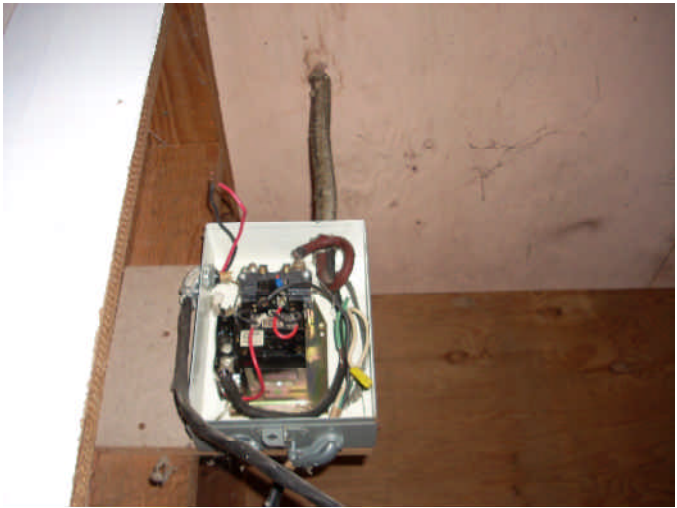
Old panel in utility closet and wiring does not appear to be active but should be **terminated properly** and contained.

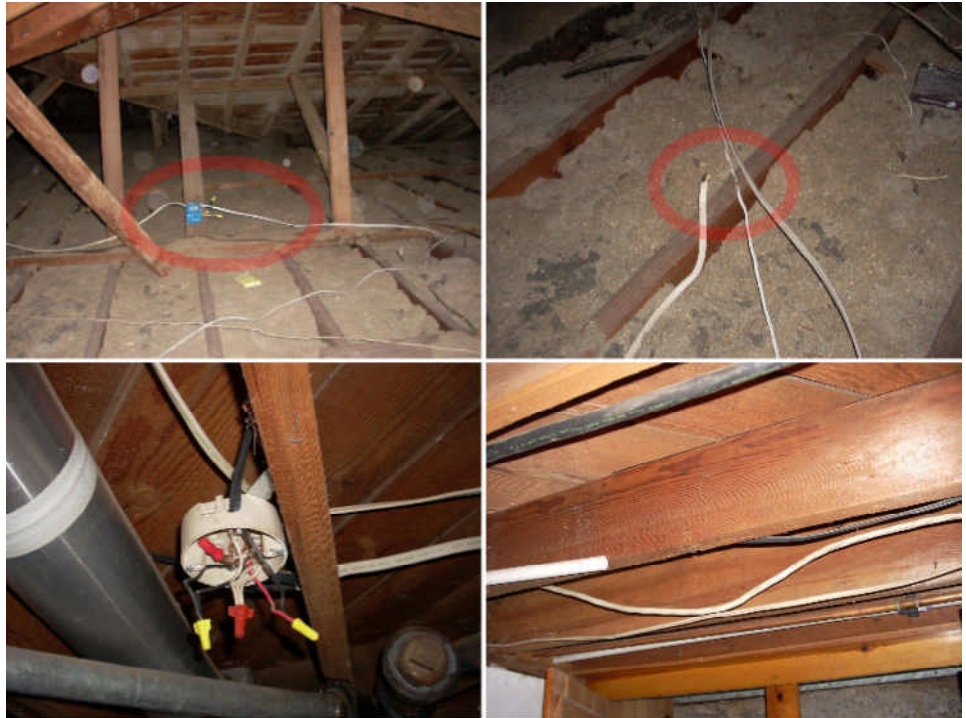
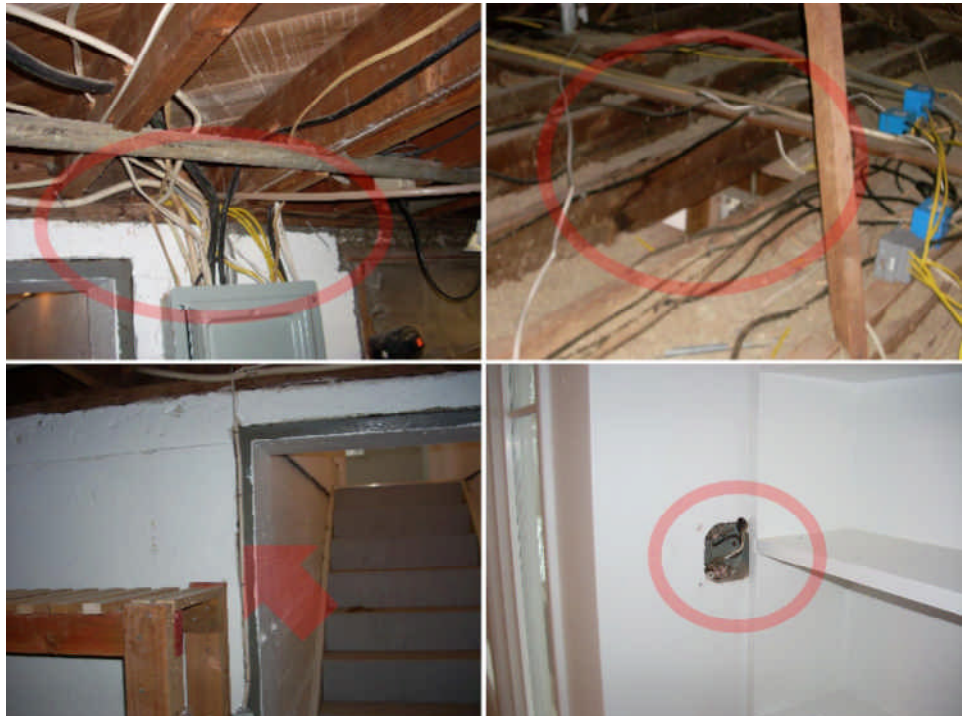
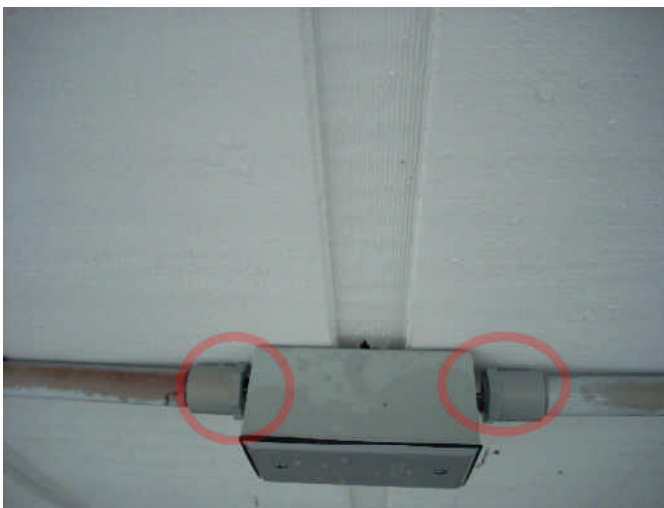
Bare wires are noted and not contained in junction boxes in attic, and crawlspace. **Open junction boxes** are noted in attic and in south bedrooms on walls, and basement. Cables **inadequately** attached or protected/ lacking conduit where needed where below floor joists in basement, improperly secured in crawlspace and attic. Wiring **too close** to attic access opening in utility room from attic. **Open grounds** noted on outlets throughout majority of house. **Damaged** conduit noted along east bonus room at exterior. **Recommend** licensed electrician evaluate system and deficiencies and remedy all concerns.

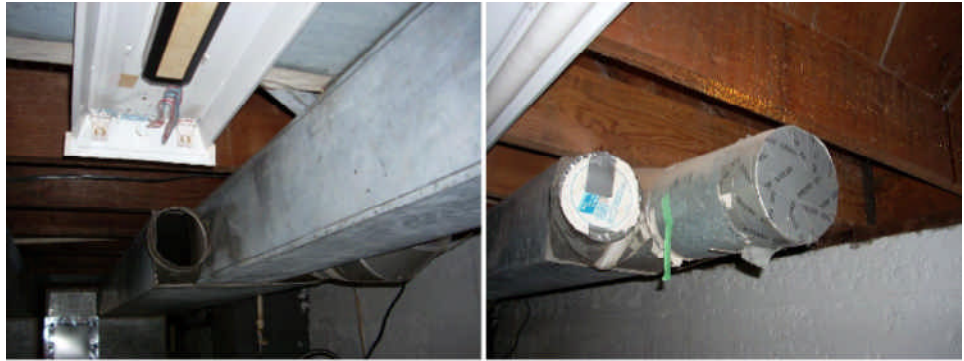
Clean **debris** from ductwork, Lacking benefit of heat source in each room- none noted in master bathroom and NE bonus room. Ductwork has been **disassembled** in basement and is no longer servicing a few rooms (kitchen, utility room)- budget for repairs to ductwork.

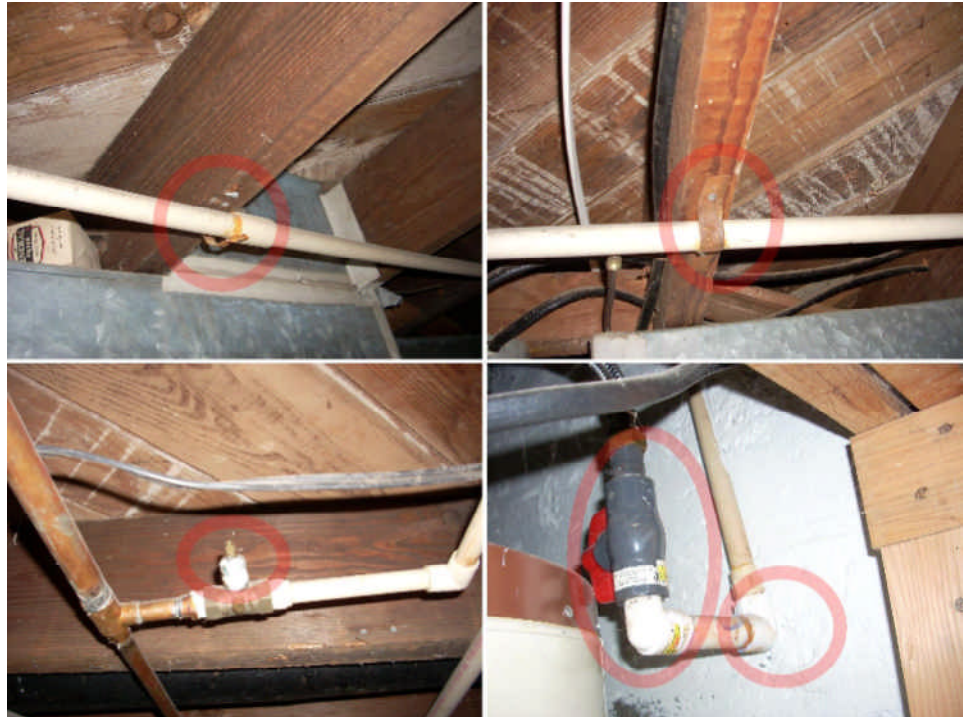
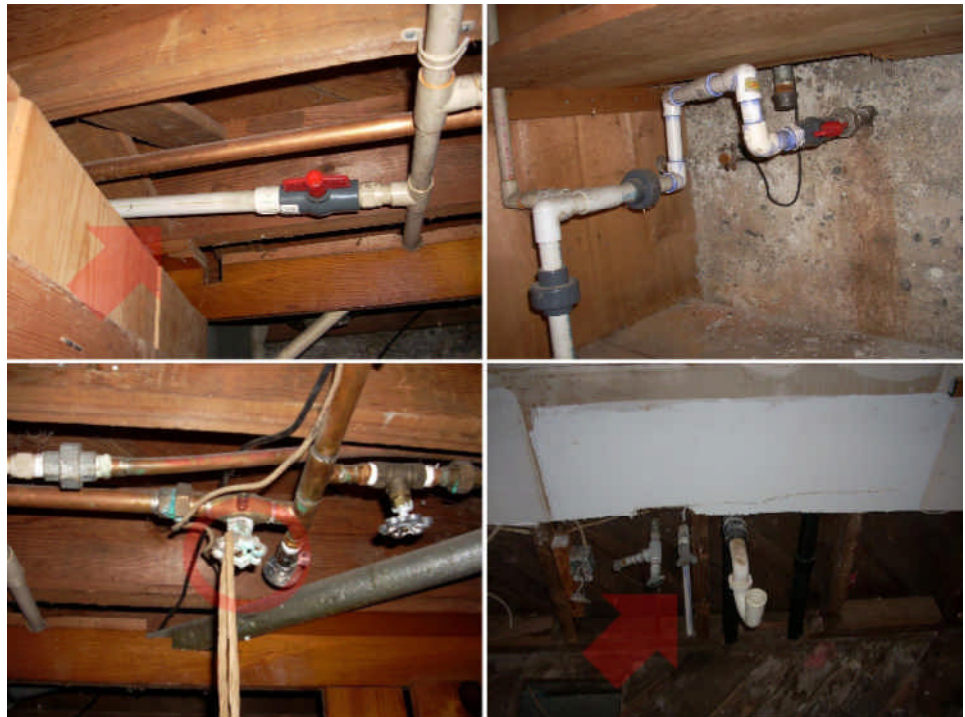
Numerous signs of amateur plumbing repairs and installations, pvc pipe prohibited at interior of structure (currently services numerous areas in kitchen and utility room and lines in basement.) also pvc fittings used with CPVC pipe (prohibited), missing valve handles, worn valve handles and improper materials for valves. Some loose and broken pipe supports and metal hangers used on plastic pipe (prohibited) . Recommend licensed plumbing contractor evaluate and repair/replace fresh water pipes to industry standards.

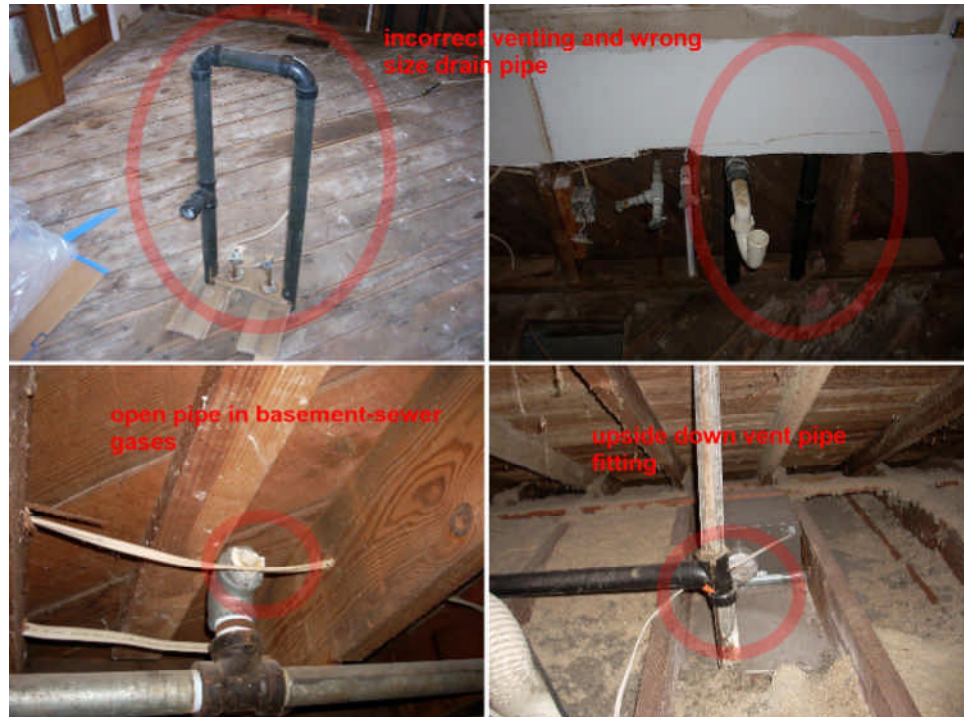
Numerous signs of improper and substandard/altered DWV system. Improper fitting at south basement under hall bathtub drain, Open pipe in basement-sewer gases escaping into basement from drain line, Improper island venting at kitchen sinks and improper drain size. Lacking trap for washer drain, Improper and upside down fittings on DWV in attic, **Recommend** licensed plumbing contractor evaluate and repair/replace DWV system to industry standards. Alterations and repairs to DWV systems require permits/finals- unknown if present. Appears serviceable.

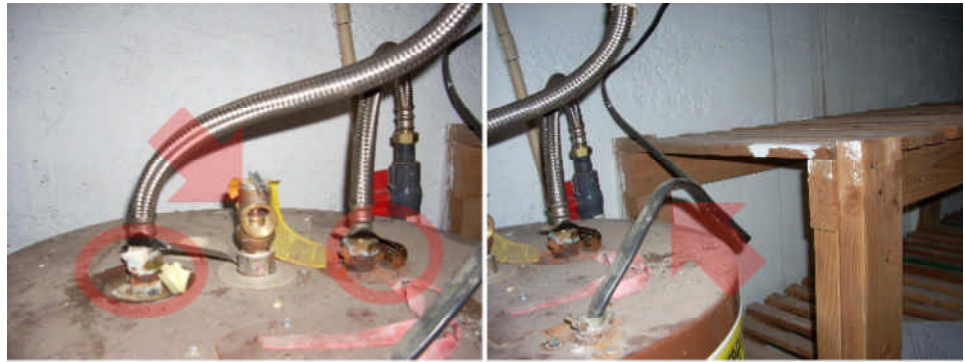
Hot water heater is **older** and may be nearing the end of its useful life, budget for replacement in near future, **Seismic support** is inadequate or missing. Recommend support to industry standards, **Improper/amateur** wiring conditions-lacking protective conduit. **Rust/corrosion** at supply stubs, recommend cleaning. Pressure relief valve drain line is **missing or ends prematurely**. Recommend this drain line be extended to a safe location, 6-8inches off the concrete floor, Hot water heater is **winterized or utilities off** and unable to test.

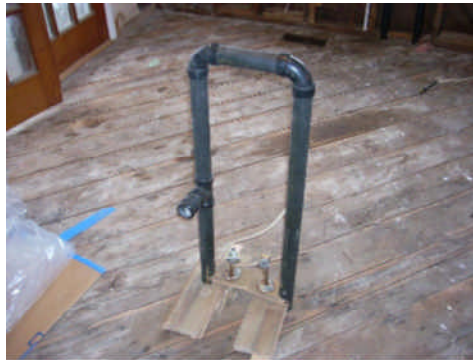
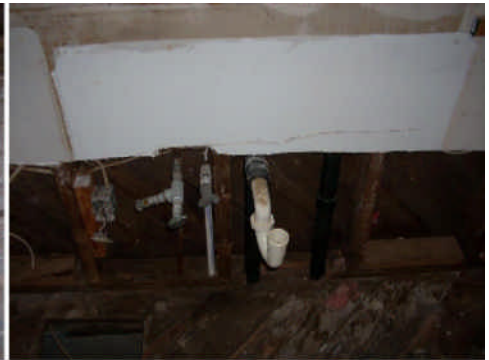
Sink and fixtures have been **removed**. **Improper** and amateur DWV system and PVC water lines prohibited to interior fixtures. Recommend licensed plumbing contractor repair to industry standards prior to replacement of plumbing fixtures.

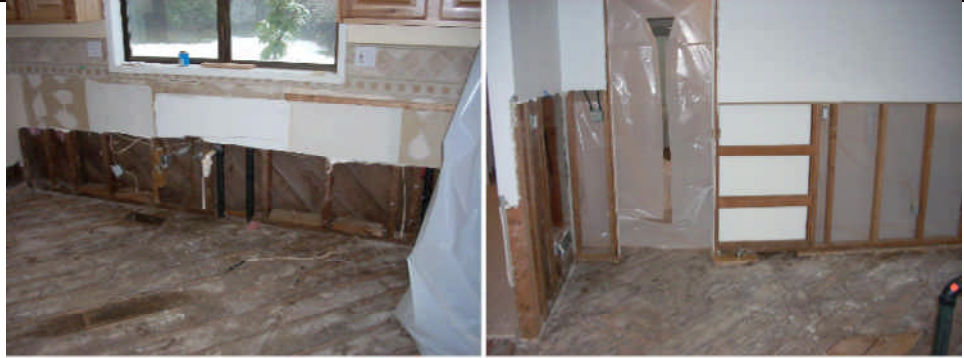
Countertops have been **removed** for demo- budget to replace to industry standards- amateur installation noted to granite countertops.

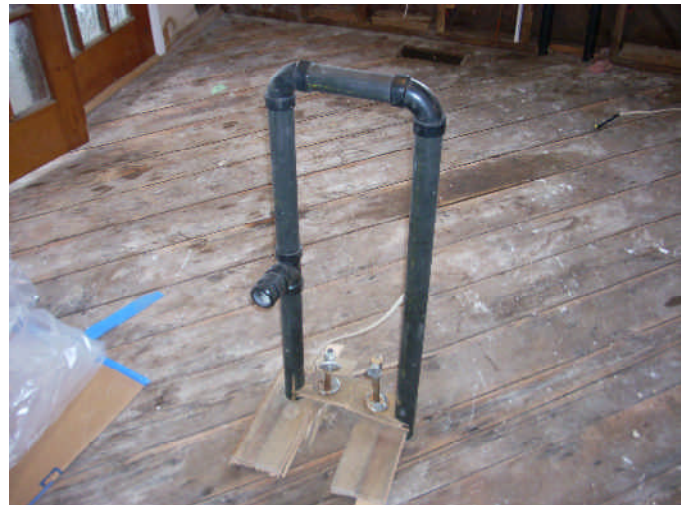
Cabinets have been **removed** for demo- budget to replace to industry standards.

Lumber subfloor.
Wood flooring has been **removed** for demo. Budget to replace sand/finish to match- vinyl at nook to utility will need replaced also.

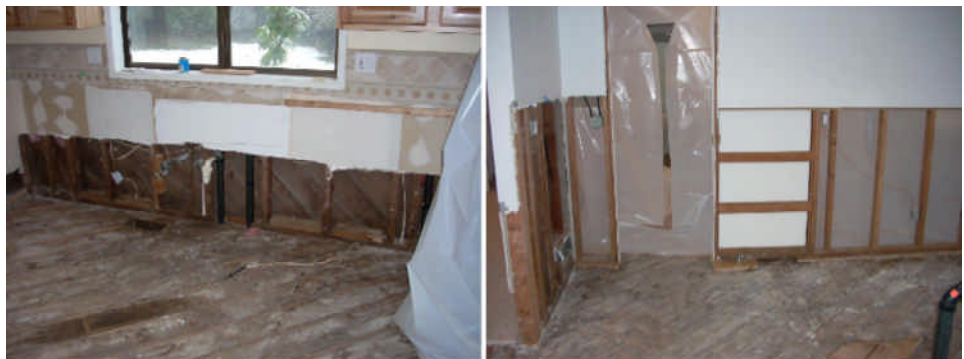
Open grounds to outlets- improvements needed, Inoperative outlets noted- may be turned off in panel. Loose fixtures and outlets and bare wiring. Budget to rewire to industry standards as kitchen is put back together. Outlets within 6 feet of kitchen sink are GFCI protected.

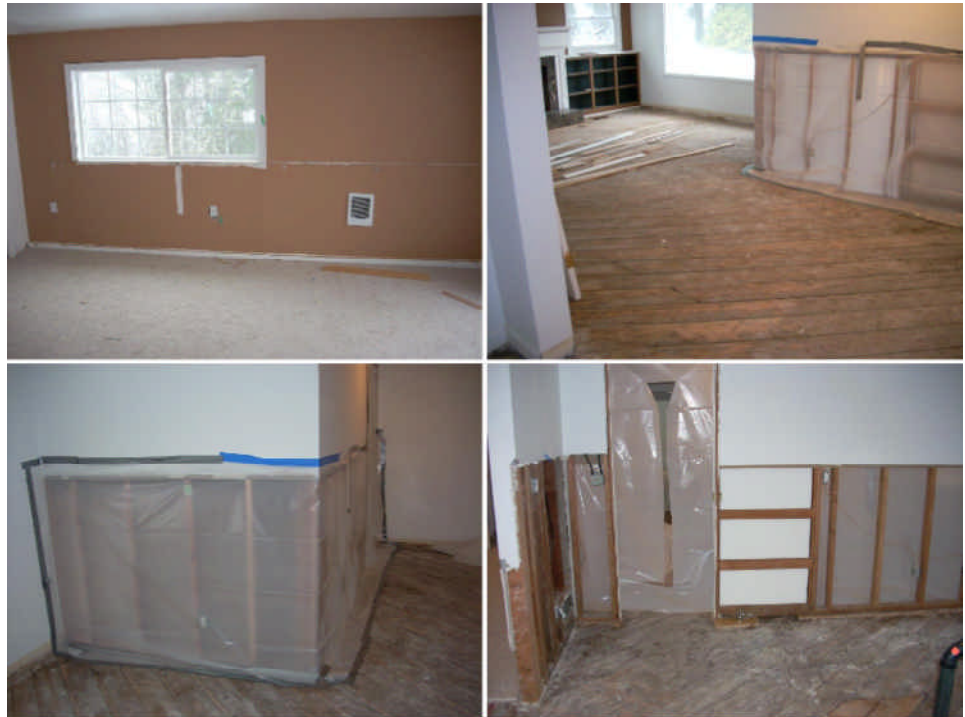
Drywall, Plaster, Paneling, Typical cracks noted. **Holes** in wall and missing trim at east wall along east bonus room. **Sheetrock has been removed** in living room, kitchen, nook, den areas- budget to repair/texture and paint to match.

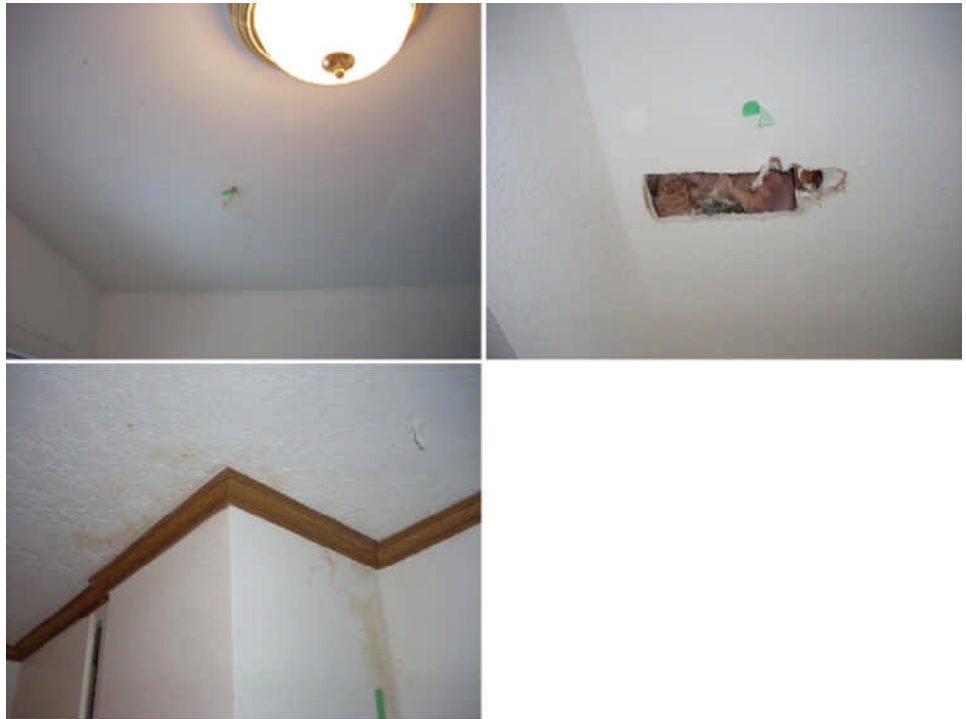
Drywall, Plaster, Typical cracks noted, **Damage noted**- holes in ceiling at east master bedroom ceiling, above stairwell to basement. Evidence of **active leakage** noted around chimneys and in utility room- damaged drywall.

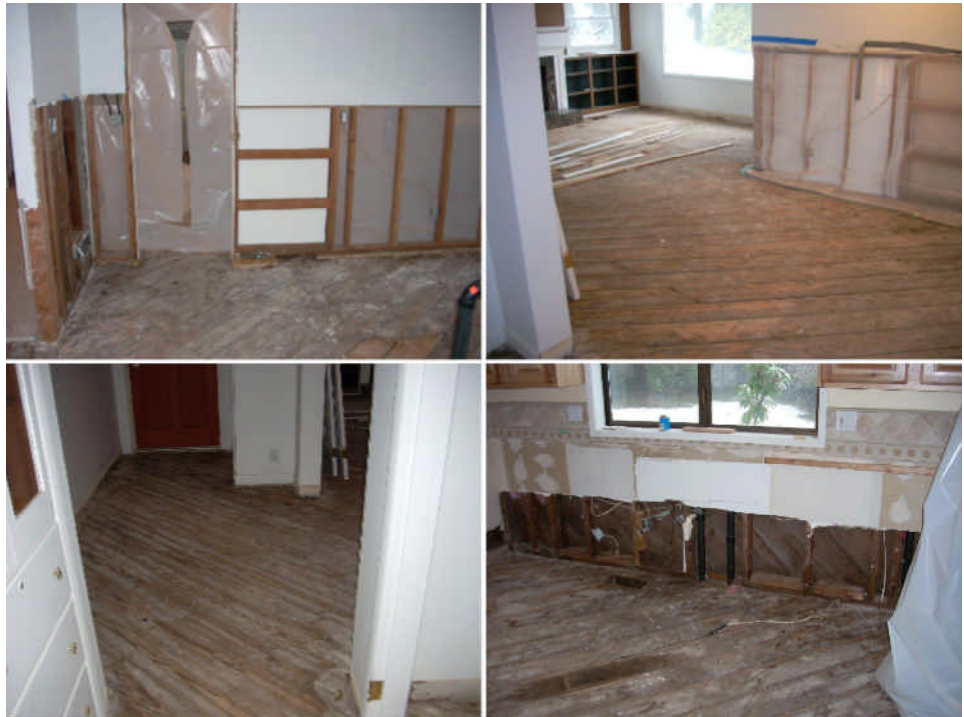
Carpet, Vinyl, Wood floors. **Wood floors and baseboard trim has been removed** in entry area and entry closets, nook, den, living room, kitchen- budget to add subfloor and replace wood floors and sand/finish to match. Vinyl flooring in kitchen, nook and utility will need **replacement** as well-it has been damaged from demo work.

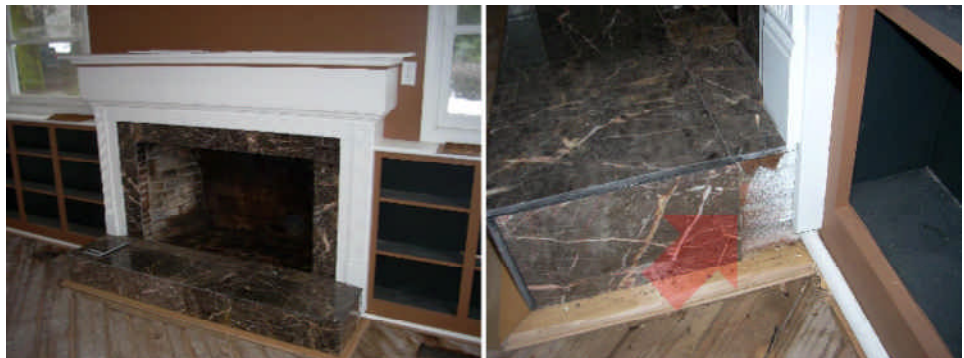
Living room. Masonry, Mortar joints are deteriorated and cracking with heavy moisture intrusion. Damper is not operational and deteriorated and rusted. Chimney is an unlined type, **Recommend** a level II safety check by a licensed chimney sweep/masonry contractor prior to purchase and repair firebox prior to use. **Insufficient** clearance to combustibles on wood trim around firebox and missing tile on sides of hearth base.

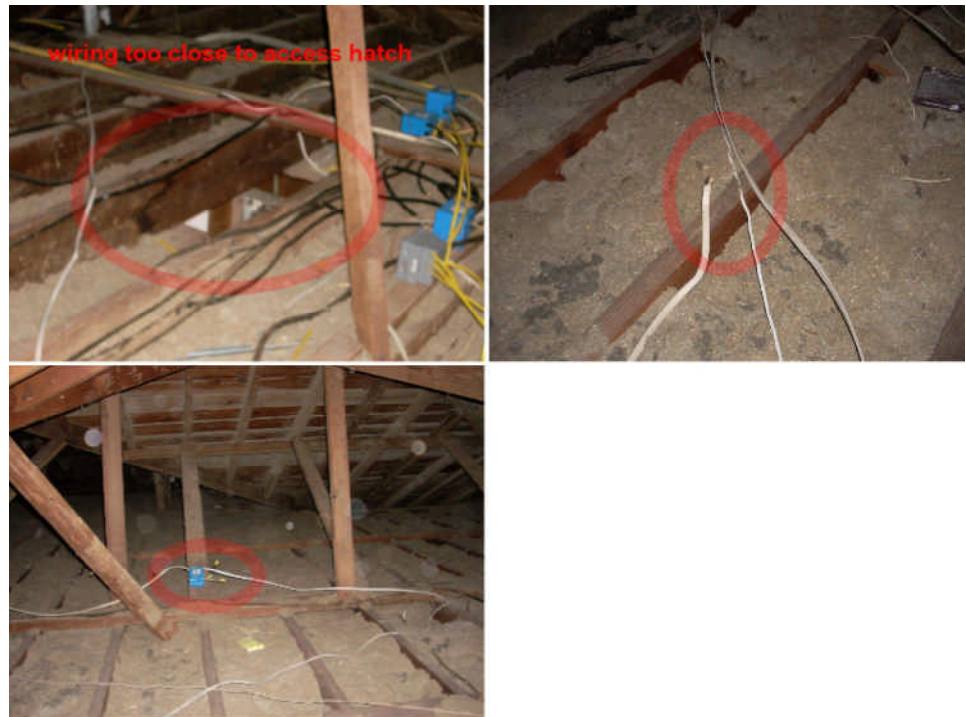
Accessible by Scuttlehole, Attic was traversed, partially only. **Lacking** access hatch. Wiring **too close** to attic access and should be rerouted. **Open** junction boxes and wiring not terminated in junction boxes.

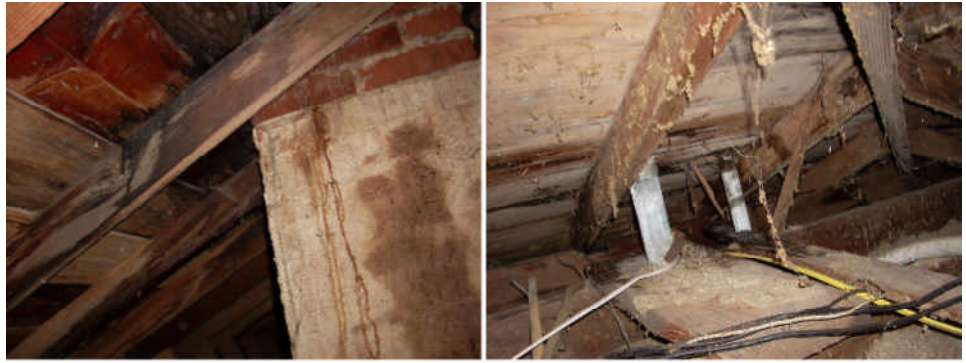
Major staining/leakage are noted in multiple areas in attic. Recommend a licensed roofing contractor make further evaluation and repairs as needed.

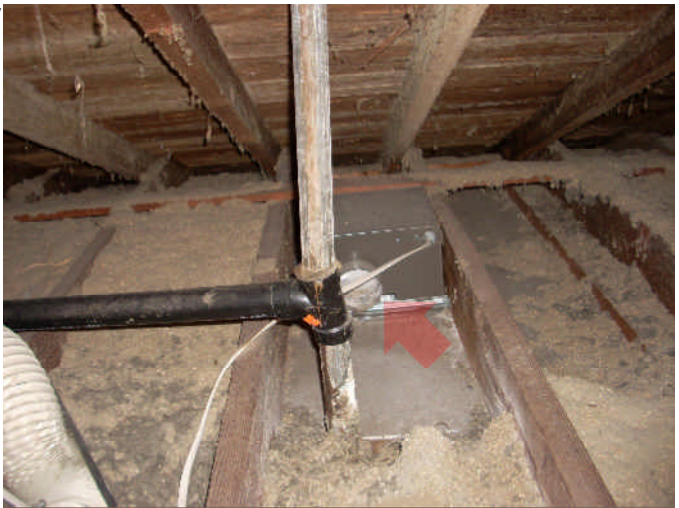
Soffit vents, Roof jacks/vents, Bathroom fans terminate in the attic- extend to roof jacks or exterior of the structure, Kitchen duct, terminates in the attic - extend to the exterior of the structure.

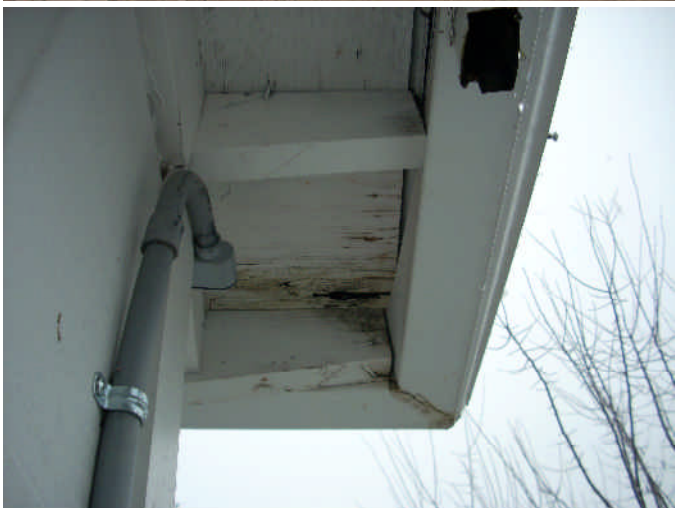
Plywood, Dry rot damage noted at NE corner.

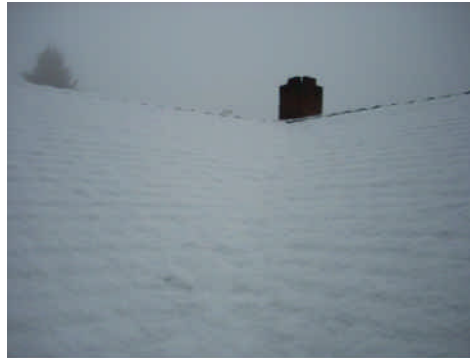
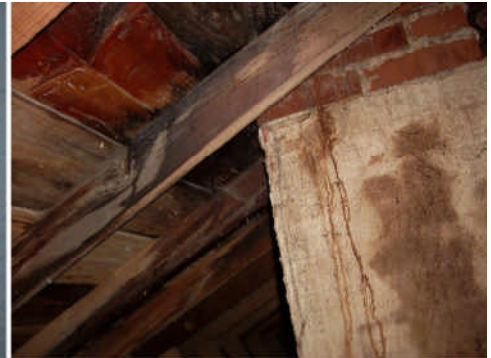
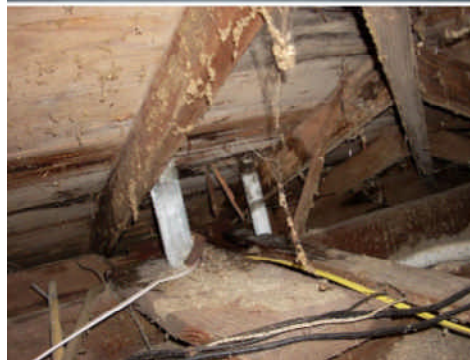
Snow cover on roof prohibits evaluation of roofing materials and flashings.
Evidence of active leakage noted in multiple areas in the attic. **Recommend**
further evaluation and repairs by a qualified licensed roofing contractor.

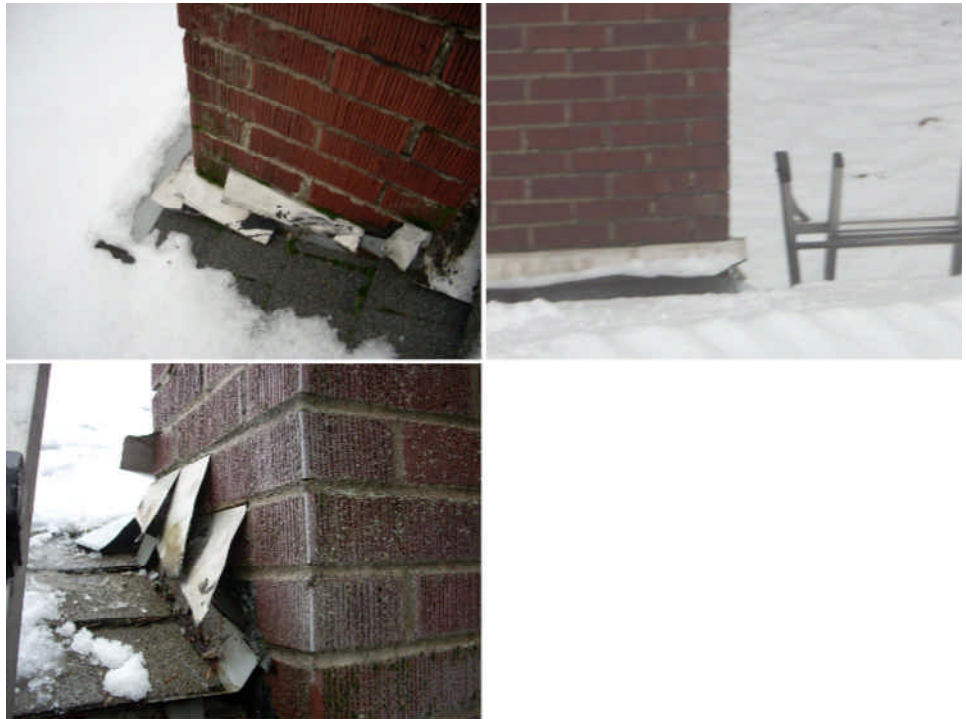
Metal, Rubber, Flashing appears to be **improperly installed/uplifting** around chimneys. A **licensed roofing contractor** should be called to make further evaluation and repairs as needed.

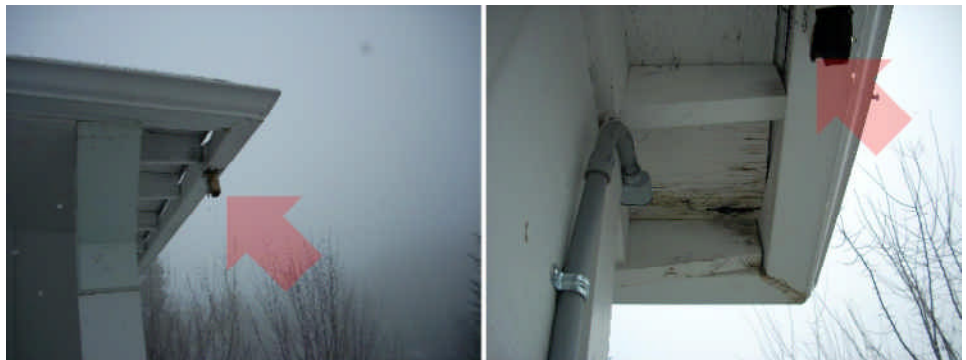
Galvanized, **Debris** in gutters and downspouts, need cleaning. **Add** downspouts to east elevation gutters. **Reconnect** SE downspout. **Add** splashblocks/leaders to all downspouts to extend runoff away from foundation.

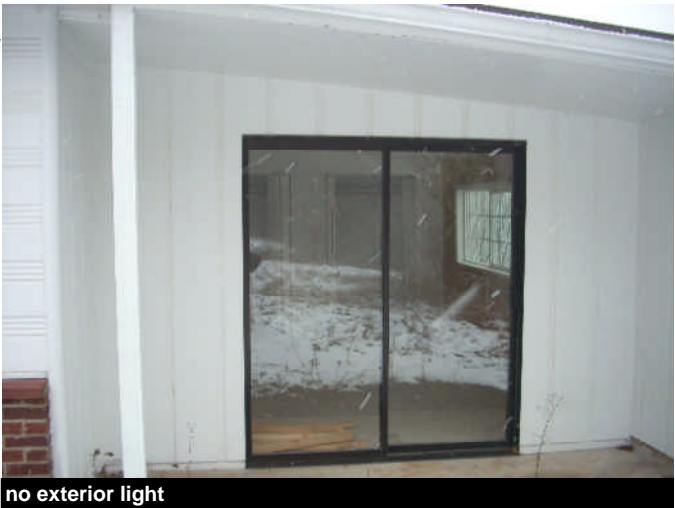
Solid core, Glass panels, Plywood panels.
Unable to open main entry door-adjustments/repairs needed.
Lacking switched lighting to properly illuminate exterior landing from door at NE and SE elevations.

no exterior light

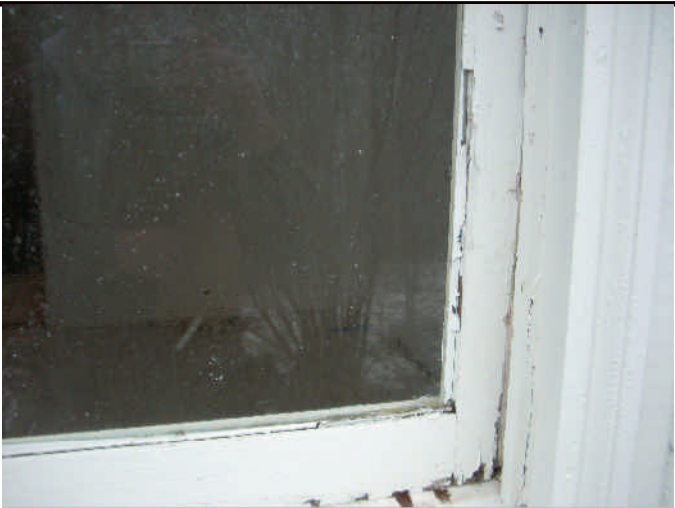
See interior remarks, **Degradation** noted to glazing on single pane wood windows. NE bonus room window is in poor condition-budget to replace.

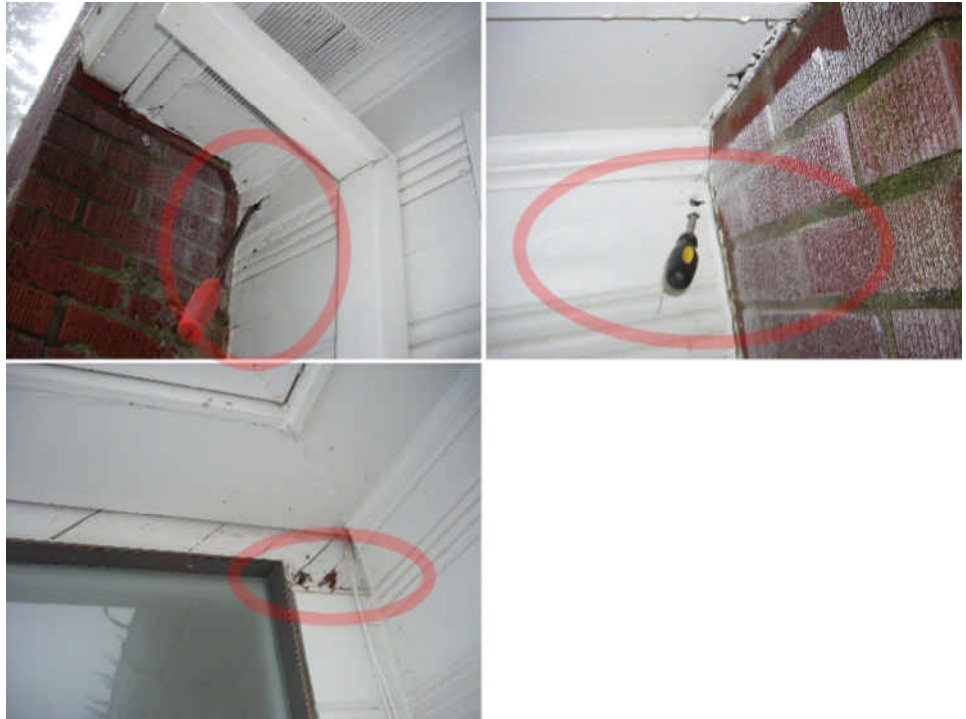
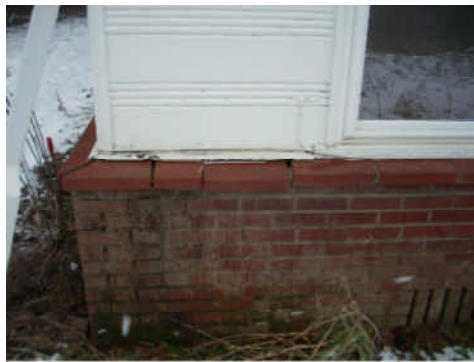
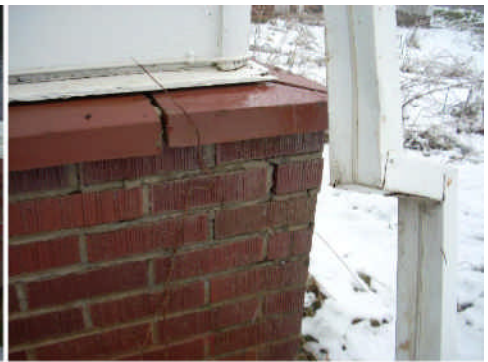
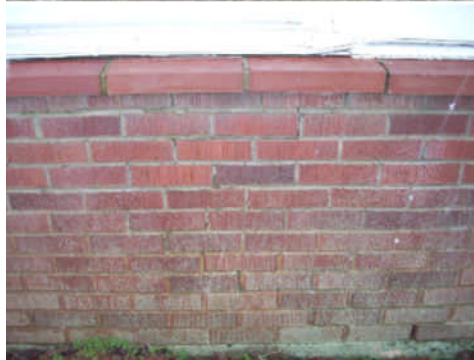
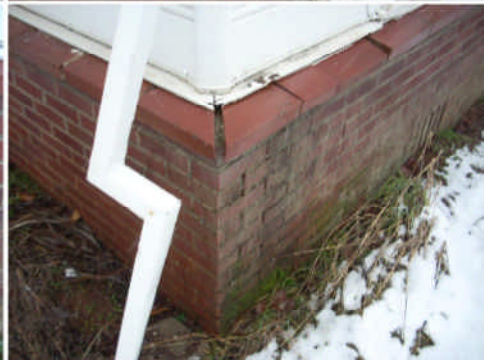
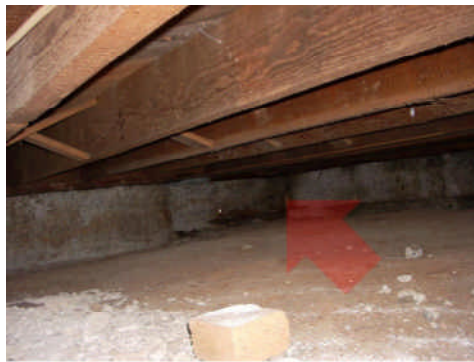
Dry rot damaged siding noted around chimney on both sides. Missing siding and trim with damaged wall sheathing above NE window of hall bathroom. **Initial** findings on brick veneer shows numerous areas where brick mortar is cracked/missing and sill mortar/brick is cracked/loose/missing and allowing moisture to substructure. Areas in crawlspace showed water dripping from foundation walls and sills and rim joists due to moisture intrusion through brick veneer, **Recommend** further evaluation and repairs by a qualified licensed siding contractor and general contractor. Expect possible substructure damage. Brick planter box is not advised next to house and probably is not lined and I would expect possible substructure damage at that area as well.

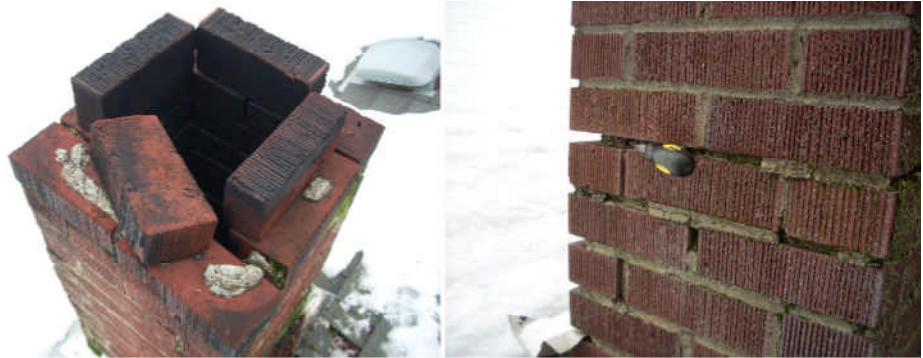
Loose bricks noted, **Deteriorated** mortar - repoint and tuck needed by a licensed masonry contractor, **Unlined** flue, **See interior** remarks.

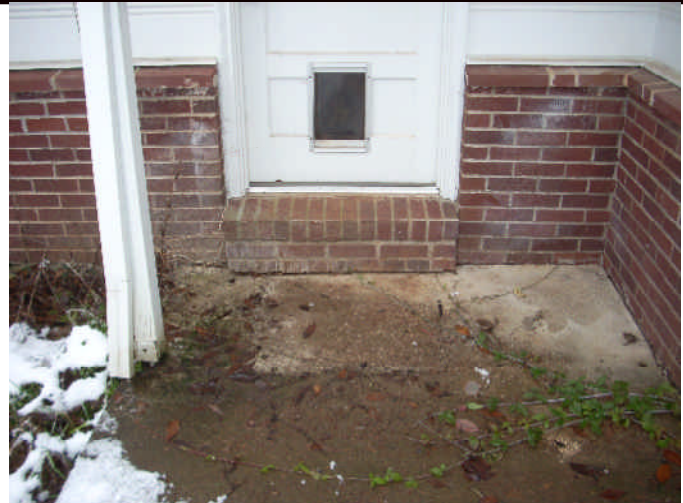
CONDITION: Steps on north side of structure **exceed** today's standards of height from threshold to grade.
