Inspection Report
Nowhere Important
Rural, OR
Prepared for: Nobody You Know

Report Table of Contents

REPORT #: 12144.
DATE OF INSPECTION: 1/7/2008.
TIME OF INSPECTION: 9:00 AM.
CLIENT NAME: Nobody Important.
CLIENT CITY/ STATE/ZIP: ,
CLIENT PHONE #: 503-555-5555.
CLIENT FAX #:
INSPECTION SITE: Country LN.
INSPECTION SITE CITY/STATE/ ZIP: Rural, OR.

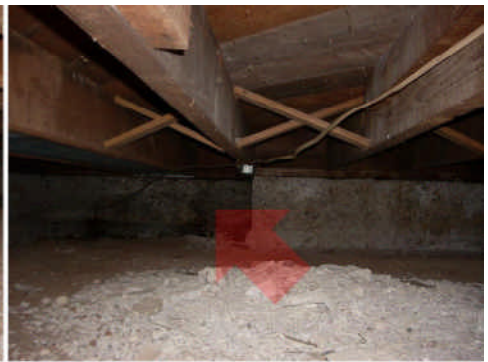
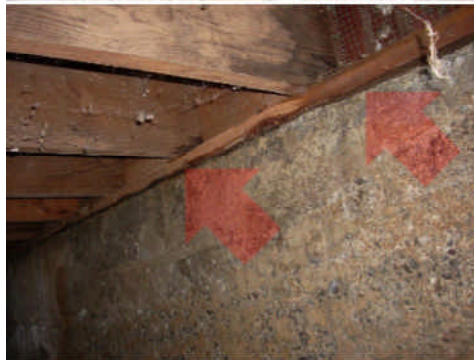
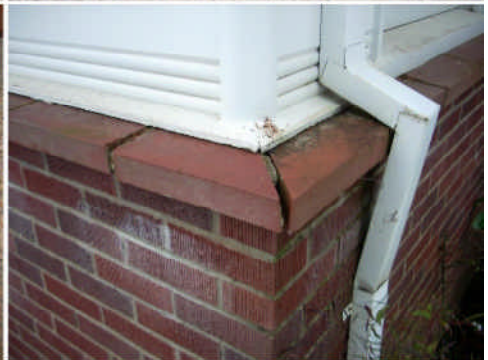
Dry rot damaged siding noted around chimney on both sides. Missing siding and trim with damaged wall sheathing above NE window of hall bathroom. **Initial** findings on brick veneer shows numerous areas where brick mortar is cracked/missing and sill mortar/brick is cracked/loose/missing and allowing moisture to substructure. Areas in crawlspace showed water dripping from foundation walls and sills and rim joists due to moisture intrusion through brick veneer, **Recommend** further evaluation and repairs by a qualified licensed siding contractor and general contractor. Expect possible substructure damage. Brick planter box is not advised next to house and probably is not lined and I would expect possible substructure damage at that area as well.
